## TILMEN HÖYÜK: A SUMMARY OF THE RESULTS AND A PHOTOGRAPHIC ATLAS OF ALKIM'S EXCAVATIONS OF THE 2<sup>ND</sup> MILLENNIUM BC LAYERS

*Refik Duru*

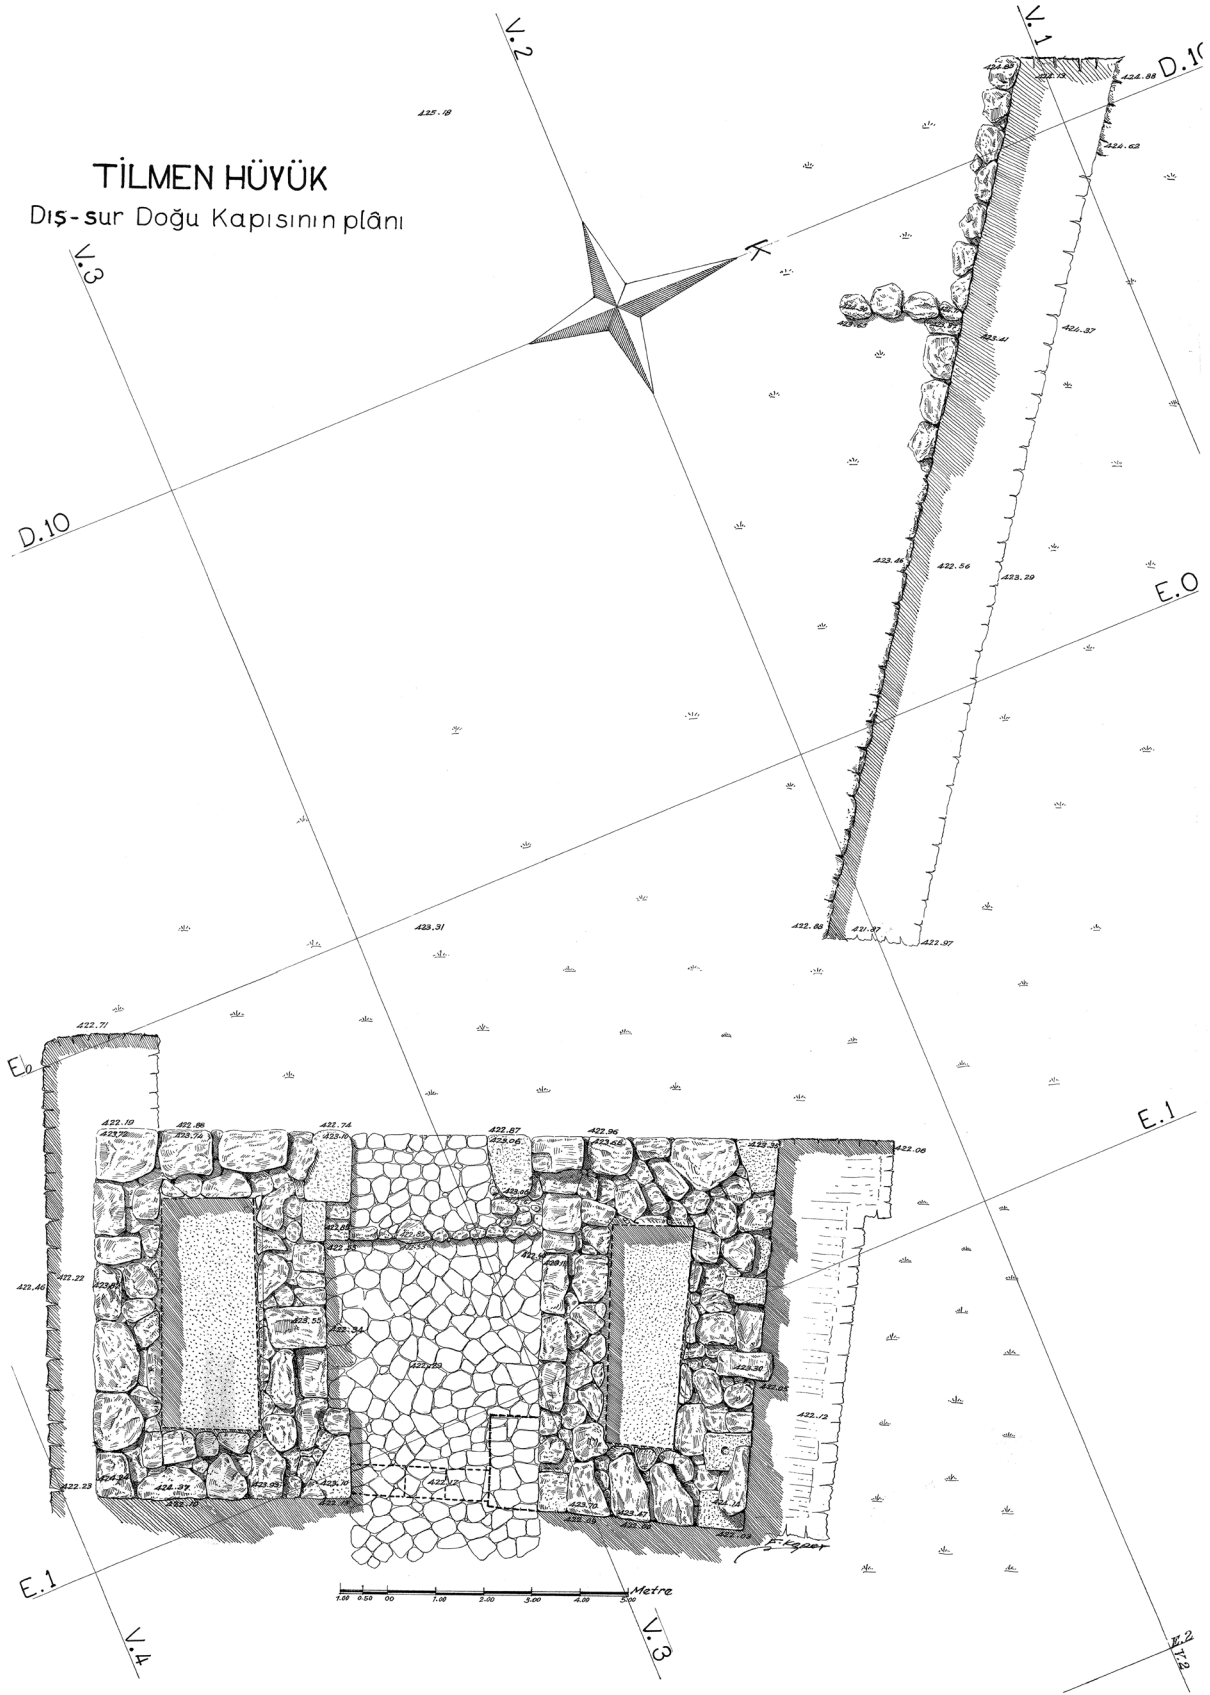
Fig. 2. Plan of the outer Main Entrance Gate (K-6) on the eastern side of the Outer Wall.

Three gates in the Outer Wall providing entrance into the city were identified on the East, North and West sides. The main entrance to the city (K-1) was from the East (Pls. VI-VIII). Between the gate thresholds, at both ends of the apparently fairly plain passage between the blocks at K-1, a central door formed a small gate room or inner court. This entrance was renovated at a later period, probably due to some defence concerns, and a second Gate (K-6) was added 22 m outside of K-1 (Fig. 2). This gate, which was not organically related to the Outer Wall but linked to Gate K-1, was in the form of a passage between two towers. These towers were made with very large stone blocks and two lion-shaped stone blocks had been placed on the outer front. An interesting factor is the extreme difficulty of the approach to the monumental gates, even though this is the main entrance to the city. This is because the approach road to the front Gate K-6, that begins at a distance of around 50-60 m away, is made of fairly large uneven stones. This road is even difficult for a person to walk on and suggests that entrance to the city was made deliberately difficult.

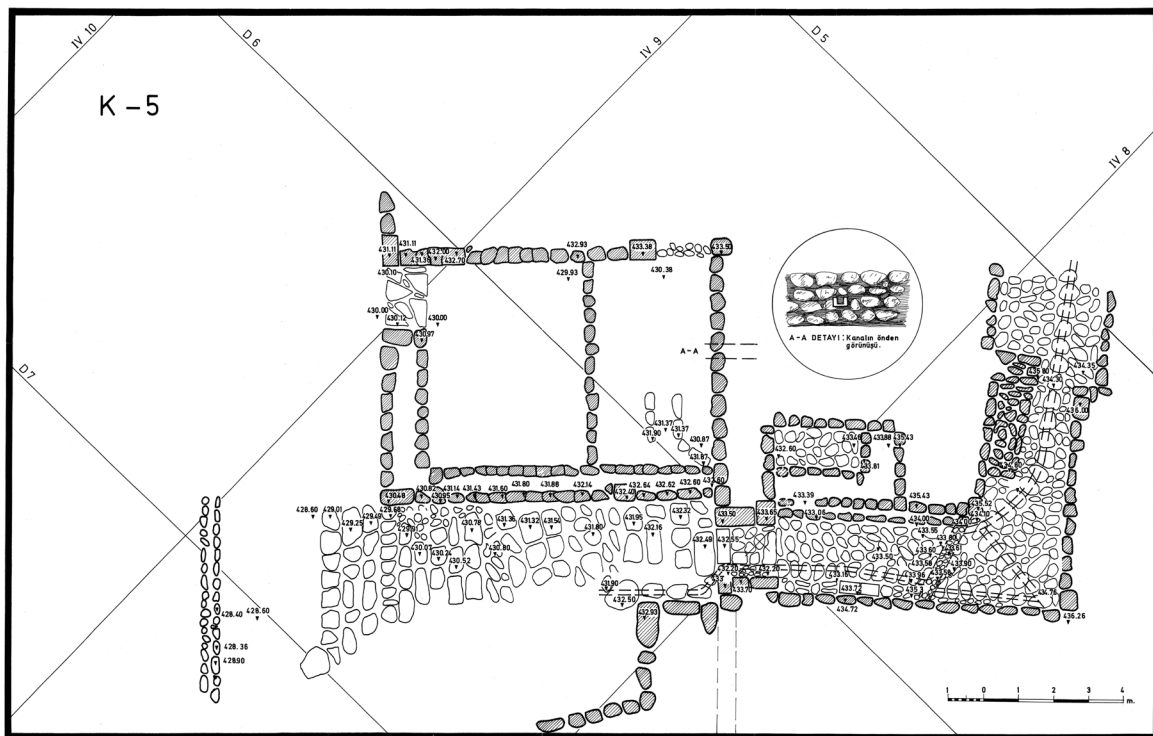
Fig. 6. Detailed plan of the stairway of Gate K-5.

There is one entrance in the Inner Wall: K-5 (Figs. 5-6, Pls. XIV-XIX.1). Situated on the steeply ascending eastern slope of the höyük, K-5 consists of a lower section with steps, a gate and a corridor that extends from the gate at a sharp angle: the 13 m difference between K-5 and K-1 and the flat area of the Palace Complex is done by means of this gate. The first 5 m of this distance are covered by an ascending slope leading to the bottom of the steps in front of K-5, then after 17 steps a height of 8.5 m is reached and the remaining 4.5 m are covered by means of the room inside the gate and the gentle ascending ramp in the corridor. The steps are in the form of an independent unit outside the gate system, between the blocks that make up the inner wall. Like the other gates, the gate at the top of the steps consists of a front threshold, a small inner gate area and a rear threshold. The path/corridor, with a ramp that continues inside the gate area, extends to the South after the inner threshold in the direction of the palace.
